Vehicle Impacts in V-Ditches

Abstract. V-ditches represent a significant portion of the roadside environment in Sweden and Finland. The consequences of vehicles leaving the road and entering V shaped ditches are not well documented in simulation or experimental studies. A series of tests were conducted to document the behaviour of passenger cars entering V-ditches. Test conditions ranged from 5 to 20 degrees and 80 to 110 km/h. The tests resulted in many vehicles passing over the backslope and rollovers were observed in 4 of the tests. Preliminary simulations of the test conditions were not able to fully reconstruct the vehicle motions. Castor steering of the vehicle and ground contact with the vehicle chassis were the two most important features observed in the tests but not incorporated into the simulation models.

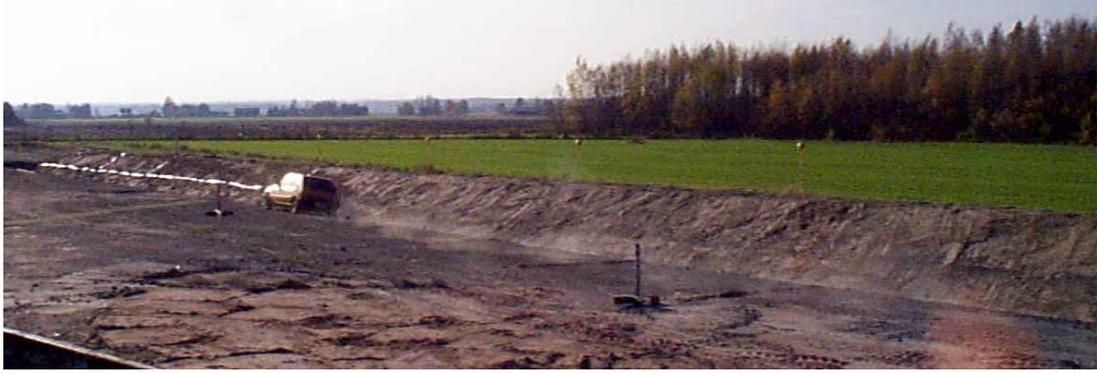
FIGURE 3: Test vehicle in ditch

The test conditions investigated are presented in Table 1. The test vehicles represent the passenger car sizes listed in EN 1317. Not all the tests were run with instrumented vehicles. This practice was chosen to maximise the number of tests. The dynamics of the vehicle in the ditch was the focus of the tests and this information could be adequately observed from the video. The trajectory of each vehicle as well as the occurrence of a rollover was recorded for each vehicle for later comparison to computer simulations. FIGURE 3 shows a vehicle travelling in the ditch during a test.

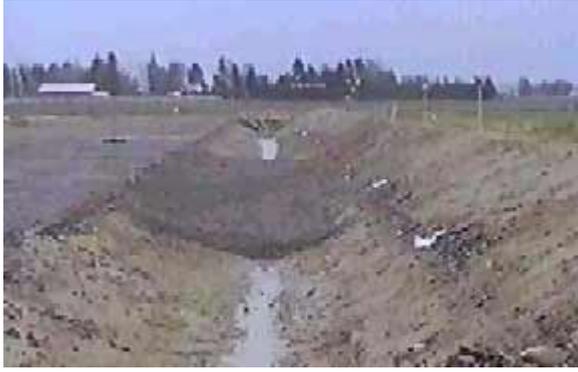
FIGURE 4: U Shaped Ditch (Loose Gravel Bottom)

The last 2 tests had a modified ditch bottoms. In one case a U-shaped ditch bottom (FIGURE 4) was investigated. In the other test a low (approx 40cm high) concrete barrier placed on the backslope about 50 cm from the V-ditch bottom (FIGURE 5).

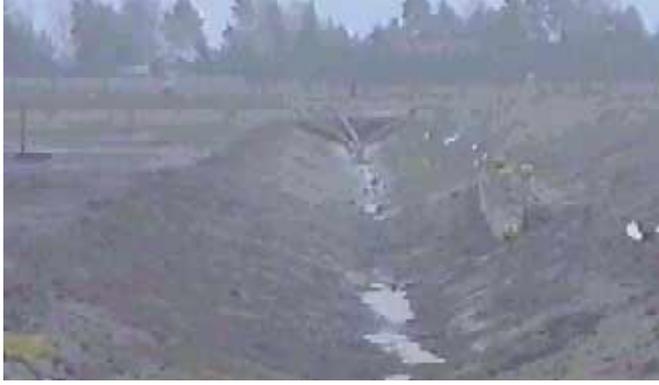
FIGURE 5: Ditch with Low Barrier on Backslope

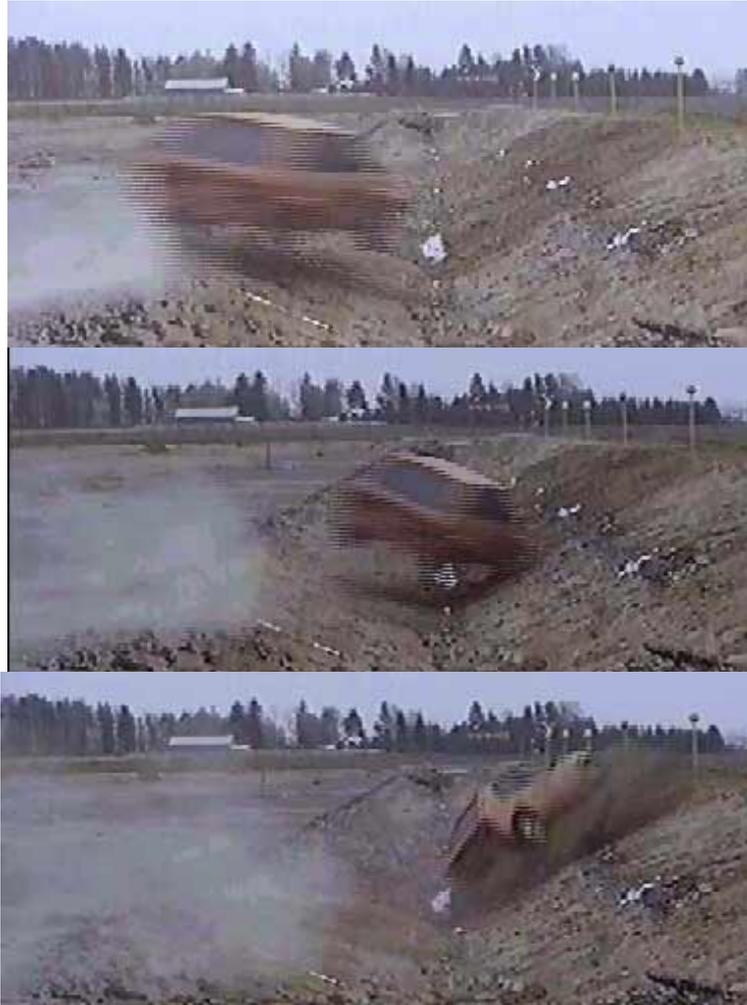
FIGURE 10: Rollover Sequence From Backslope Contact

Vehicle rollover was observed in two of the experiments where the vehicle was free rolling during the test. In both of these tests, the vehicle was seen to contact the vehicle backslope as the vehicle reached the bottom of the ditch. This backslope contact induced sufficient roll motion that the vehicle continued to rollover. One rollover occurred at a relatively low speed (79 km/h). The test with the same angle and slightly higher speed (82 km/h) did not result in a rollover, although the vehicle nearly rolled over. A much higher impact speed (107 km/h) also resulted in rollover in the ditch. A significant impact with the backslope was not sufficient to hold the vehicle within the ditch at the higher speed test.

The rollover mechanism seems to start with the first contact of the vehicle with the backslope. At a 20 degree approach angle, the vehicle does not appreciably contact the foreslope. The rightmost edge of the bumper and lower frame contacts the backslope near the bottom and induces both roll and yaw moments. It is this combination vehicle rotations due to backslope contact that sets up the rollover instability. The right front spring compresses during the initial slope contact and the resulting unloading provides additional rollover loading. This sequence is illustrated in FIGURE 10.
