HVS-NORDIC Research Report No 3

Tests 01-02 base course tests, 03-05 loading mode tests in Otaniemi

Finnra Reports 30/2001

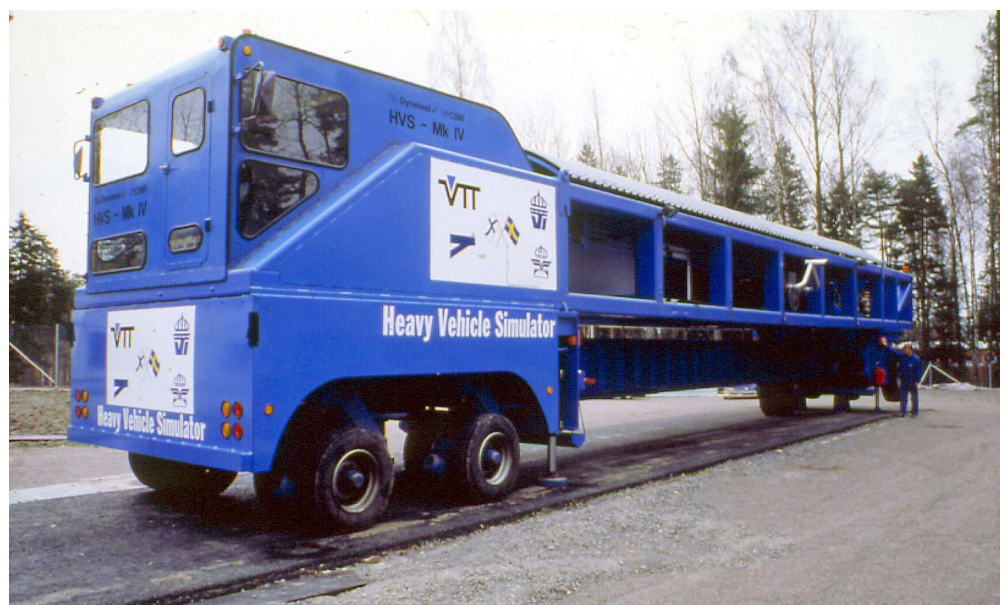
Figure 1. HVS-NORDIC

The machine is called HVS-NORDIC. The HVS Mark IV is a mobile full-scale accelerated pavement-testing facility (Figure 1). It can be run over a short distance by itself at walking speed, in practice only at the same test site. It can be moved as a semi-trailer over longer distances to other test areas or to VTI in Sweden. Since it has steering wheels, it can turn even relatively sharp corners, in spite of its long length. Its highway speed is 50 km/h, and special permits are needed.

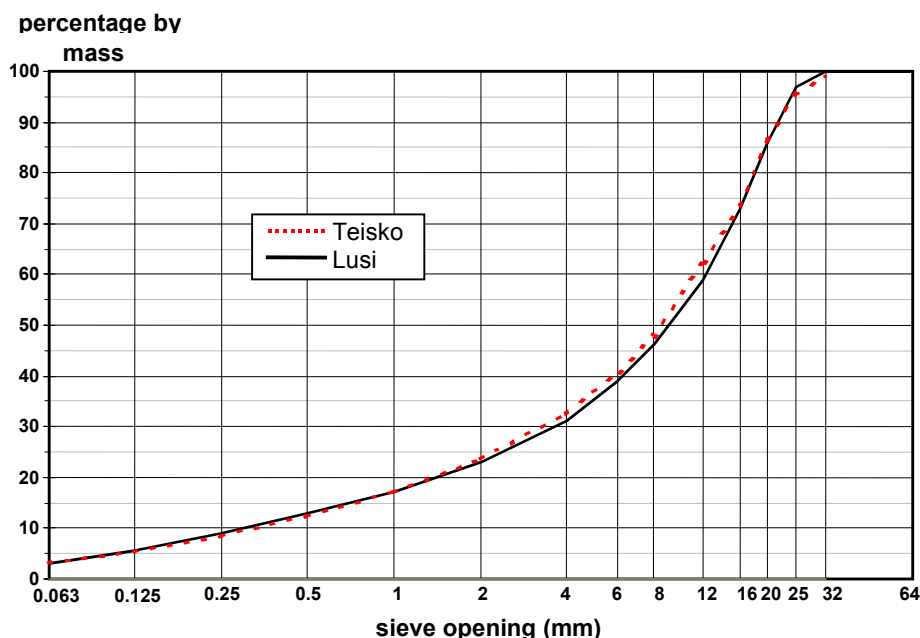
Figure 9. The grading curves of the crushed rock (Teisko-aggregate, base course material in test 02 and Lusi-aggregate, base course material in test 01 (and 03-05)).

The grading curves of both the base course materials are shown in Figure 9. They are nearly identical.

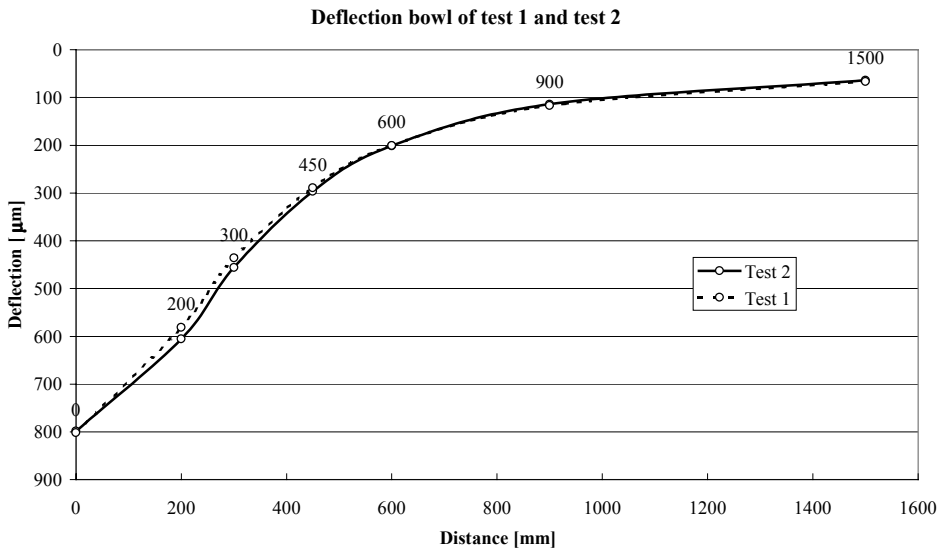
Figure 15. Deflection bowl of FWD measurements (50 kN) in tests 01-02. Pavement temperature was 7°C.

The deflection bowl of the FWD measurements in tests 01 and 02 is shown in Figure 15. The structure of test 02 seems to be a little bit stiffer, especially the upper part.

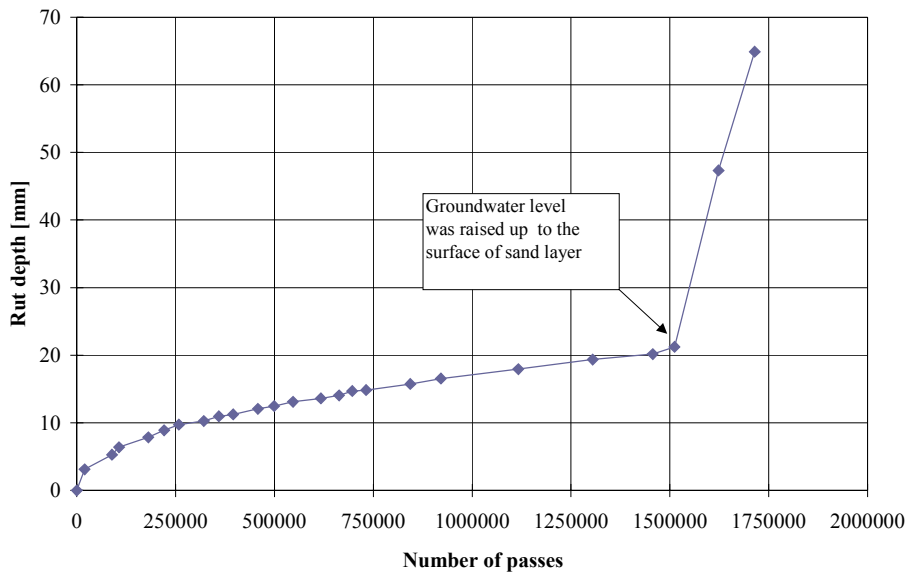
Figure 16. Rut depth vs. number of passes during test 01 (low-quality base, 60 kN dual-wheel load).

The development of rutting in test 01 can be seen in Figure 16. Test structure 01 lasted for 1.5 million load repetitions without cracks, and only 25 mm rutting was found.

The water-table level was raised from the original level (2.3 m from the road surface) to 0.3 m from the road surface (at the bottom of the base course) in order to see the effect of moisture, and in order to accelerate the test after 1.5 million load repetitions. Only 0.2 million load repetitions were needed to increase rutting from 21 mm to 65 mm.

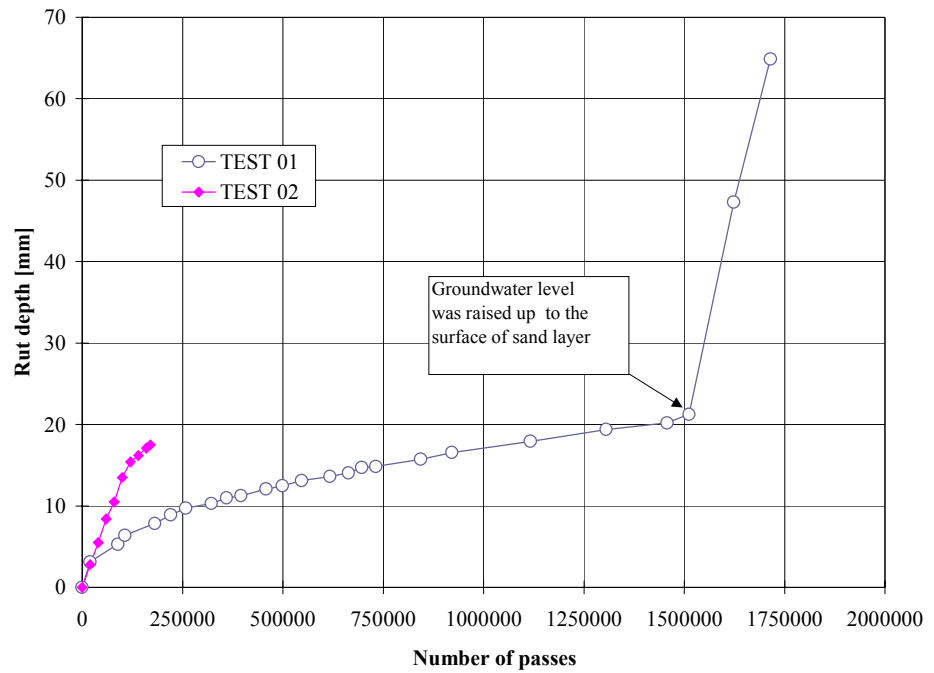
Figure 17. Rut depths vs. number of passes during test 01 (low-quality base, 60 kN dual-wheel load) and test 02 (high-quality base, 80 kN dual-wheel load).

In test 02 after 0.17 million passes, only 18 mm rutting could be seen, but no cracks. After these loadings, the test had to be stopped because thawing test constructions were made in the same test pool. The development of rutting in test 02 (as well as test 01) can be seen in Figure 17.

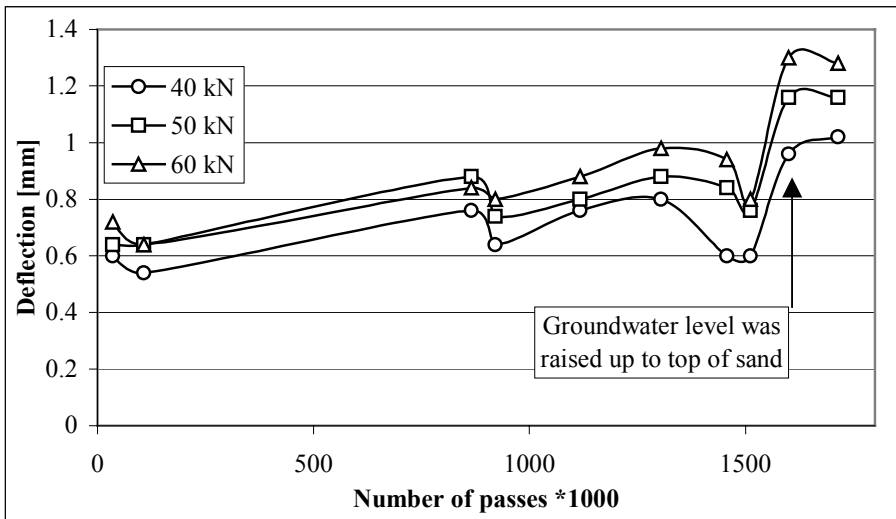
Figure 18. Benkelman beam measurements of test 01.

The results of the benkelman beam measurements in test 01 are shown in Figure 18.

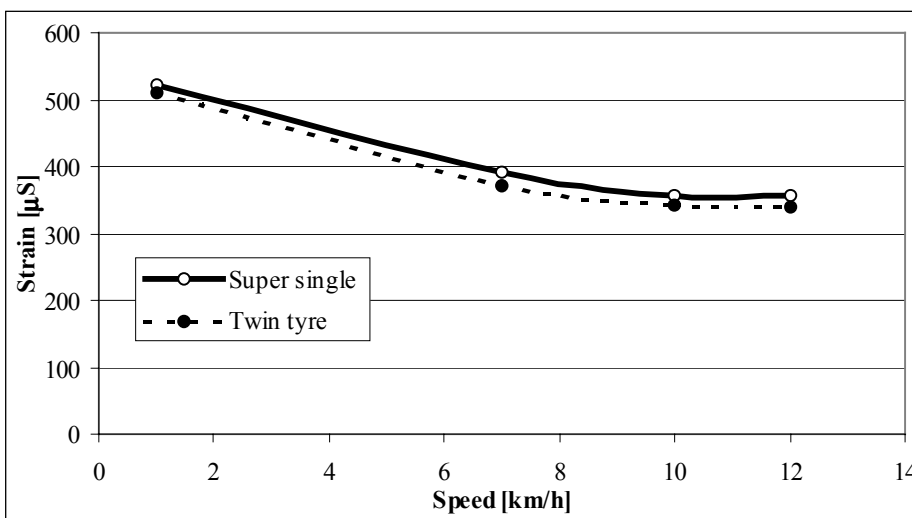
Figure 19. Typical behaviour of longitudinal strain at the bottom of bituminous layer vs. speed of loading tyre (test 01, sensor A12).

Figure 19 shows how the longitudinal strain at the bottom of the bituminous layer changes versus the speed of the loading tyre. The effect of a low speed is significant, but when the speed increases the effect decreases.

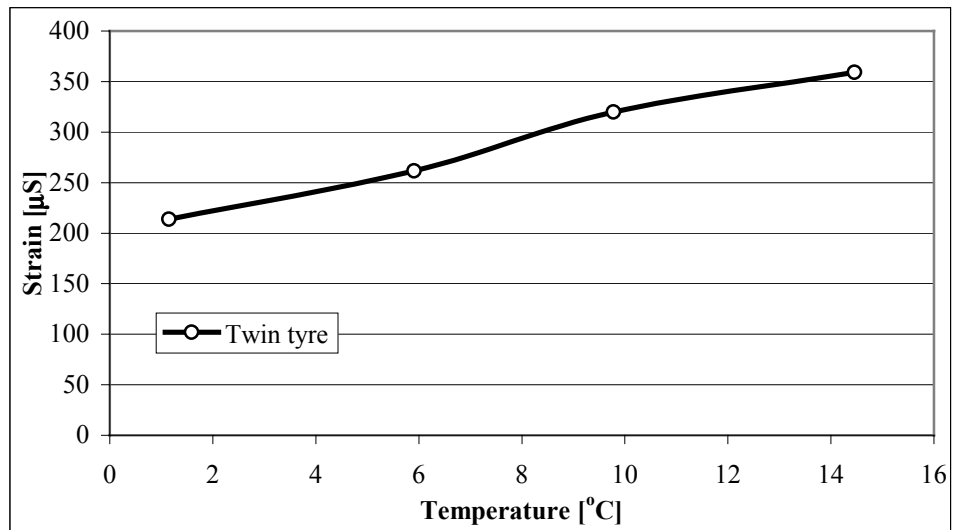
Figure 20. Typical behaviour of longitudinal strain at the bottom of bituminous layers vs. pavement temperature (test 02, sensor BB5).

The effect of temperatures on the strain at the bottom of the bituminous layer is shown in Figure 20. The effect of pavement temperature on asphalt strains is enormous. When the temperature of the bituminous layers increases from 1°C to 15 °C the strain increase 75 % (from 210 μ S to 360 μ S).

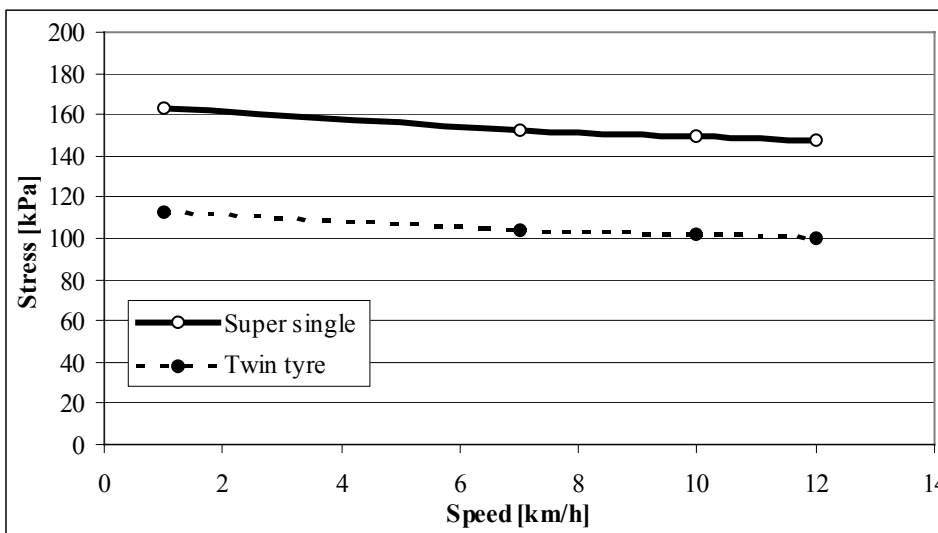
Figure 23. Behaviour of stress on the top of the subgrade (300 mm from the road surface) vs. speed of loading tyre (test 01, sensor A91).

Figure 23 shows how the stress on the top of the subgrade changes versus speed of the loading tyre. The effect of temperatures on stress on the top of the subgrade is shown in Figure 24.

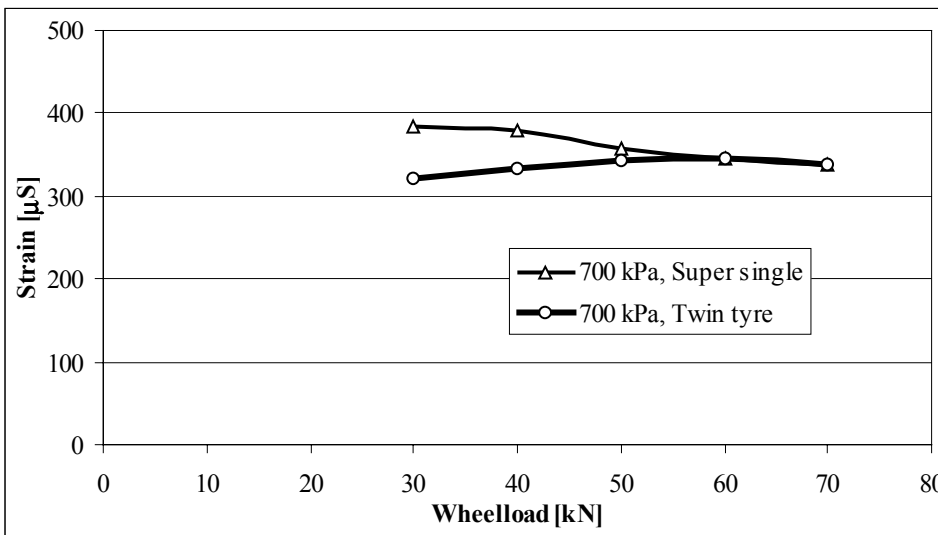
Figure 27. Measured longitudinal strain at the bottom of the bituminous layer vs. wheel load with twin and super single tyres (test 01, sensor A12).

The relationship between wheel load and longitudinal strain at the bottom of the bituminous layers in test 01 and 02 is shown in Figure 27 (sensor B14) and Figure 28 (sensor A12). The measurements show that when the wheel load is low (30 - 40 kN), the strain caused by the super single tyre is about 20 % greater than strain caused by the twin tyre. When the wheel load increases, the difference between strains falls.

The strain measurements revealed that the strains in thin bituminous pavement do not only increase with load but may also decrease (Figure 27). The reason is that the length of the contact interface between the tyre and pavement increases as the load increases at the same tyre inflation pressure. Another contributory reason is that, because of thin bituminous layers, the stress on the unbound layer is greater and consequently its modulus is greater, because?? the moduli of unbound granular materials are stress-dependent. This phenomenon has been found earlier in our response measurements at the Virttaa test site /15/.
